THE ARGO MERCHANT OIL SPILL ON-SCENE COORDINATOR'S REPORT

United States Coast Guard
Marine Safety Office
Boston, Massachusetts

December 1977

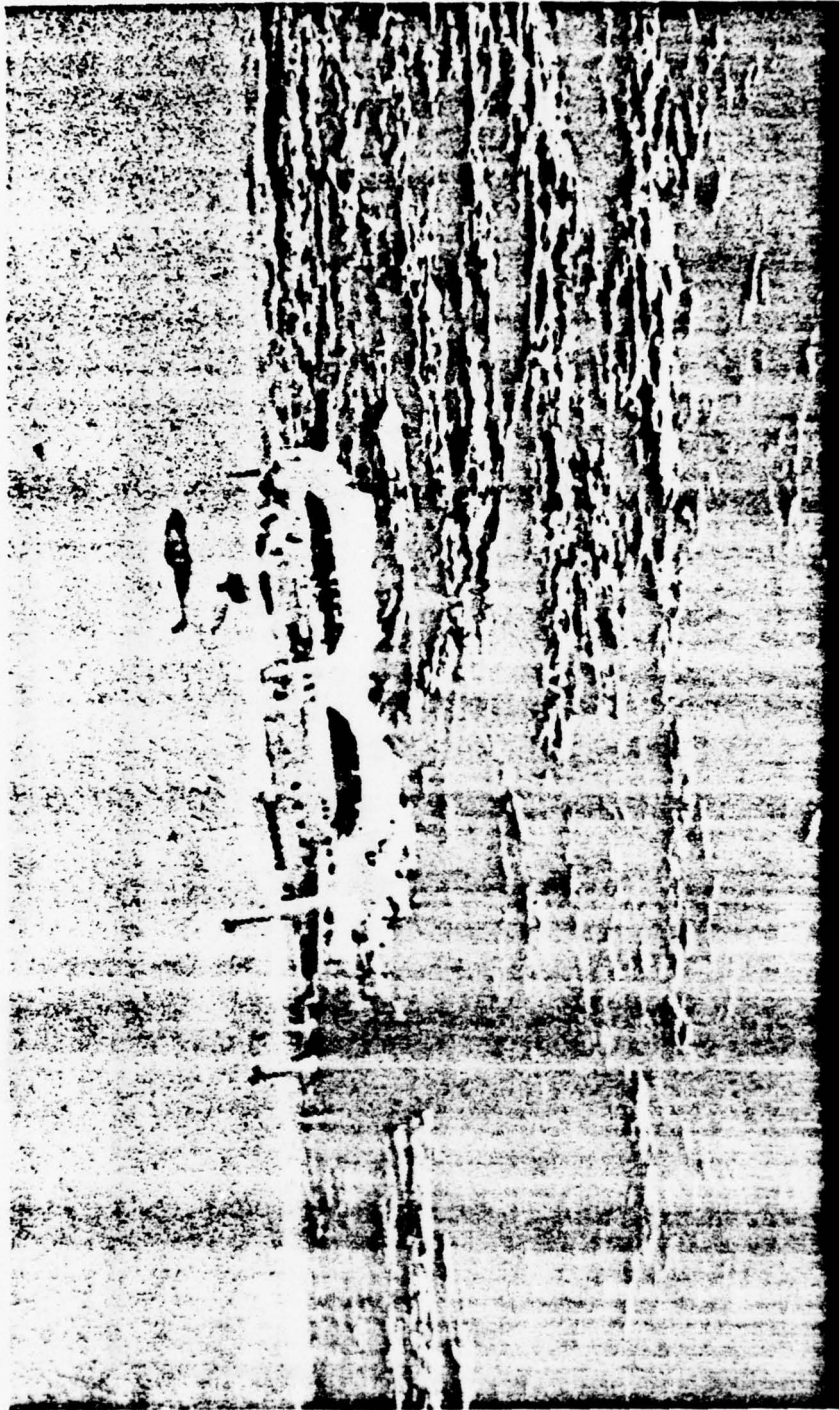
FIGURE 3 ARGO MERCHANT ON 15 DECEMBER 1976

- 0700 ARGO MERCHANT aground on Fishing Rip Shoal (Figures 3 and 4).
- 0800 MSO Boston notified of ARGO MERCHANT grounding, and the following actions were taken:

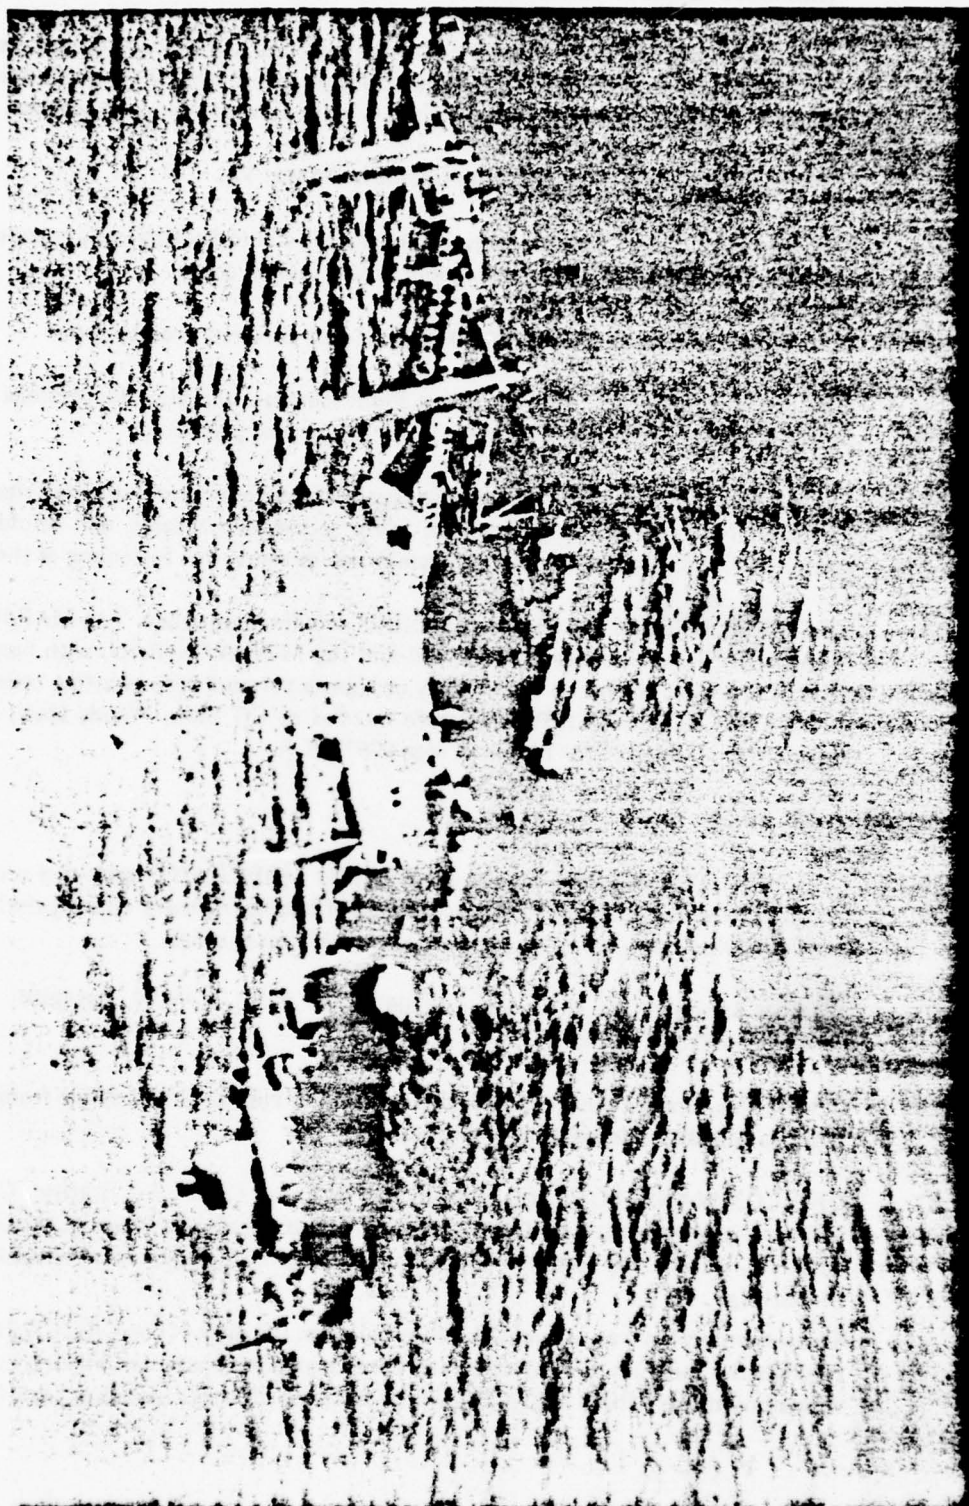
FIGURE 5 ARGO MERCHANT ON 18 DECEMBER 1976

- 0830
 - Vessel remained aground, heading 250°T, listing, 15 degrees to starboard. Vessel motion was slight, a combination of pitch and yaw. Draft reading of port bow was 32 feet, and freeboard immediately aft of forward deckhouse on starboard side was zero. Occasional waves broke as high as the stack (Figure 5). After-starboard lifeboat missing since previous day and was surmised to be adrift. Pollution significantly reduced, with very little oil coming from ullage openings. Composition of slick was unchanged, but tended to run to the Southeast and was dissipating rapidly. Heavy patches of oil about 2 inches thick and 10 feet in diameter were evident, but slick observed 17 December had reduced by about one third.

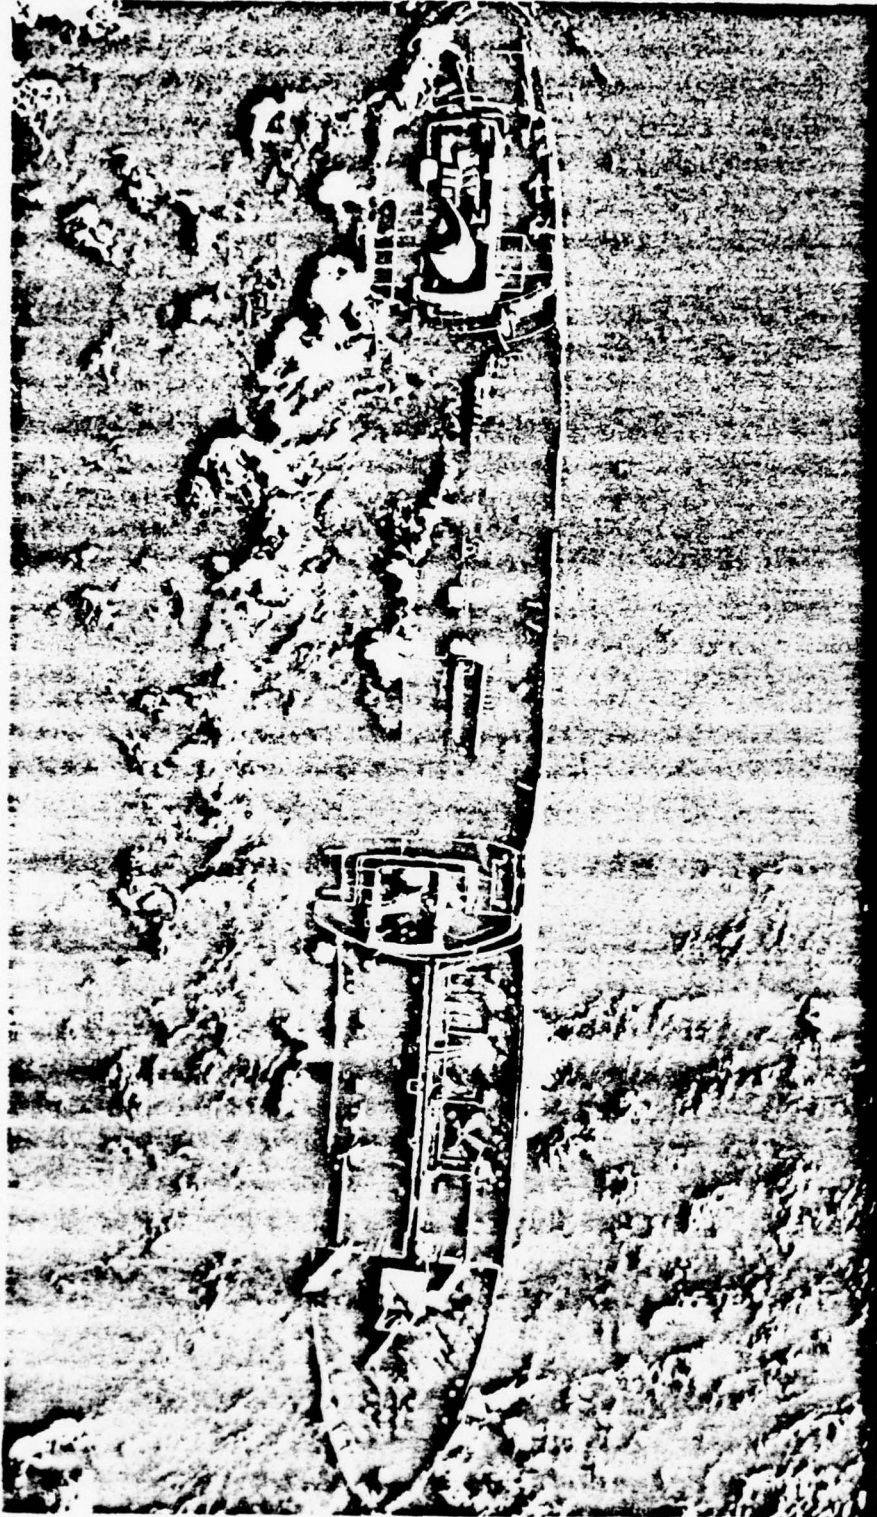
FIGURE 6 ARGO MERCHANT ON 19 DECEMBER 1976 (EPA Photo)

- 1400 Seven Strike Team personnel were placed on board the ship (Figure 6) to rig fenders. Use of a battery-powered A/N light of suitable power and characteristics planned for vessel as a warning to shipping.

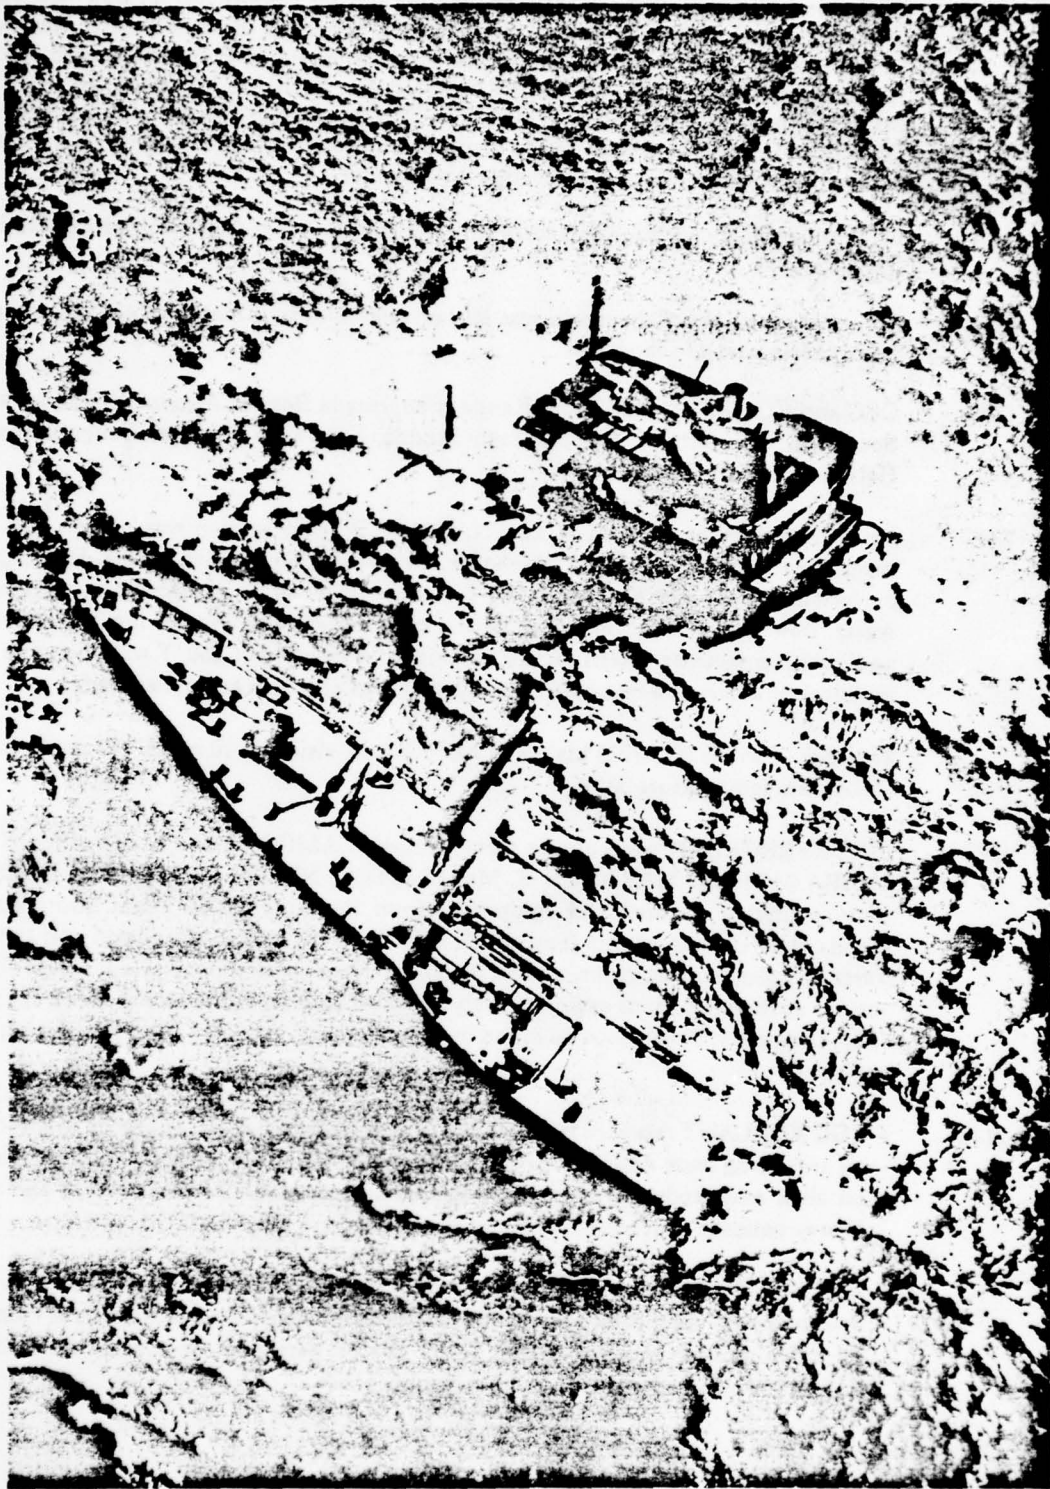
FIGURE 10 ARGO MERCHANT ON 22 DECEMBER 1976 (EPA Photo)

0730 Condition of stern section was unchanged, but deck was awash by 3 feet (Figure 10). Bow section was still driving into stern section due to seas and wind. Bow was in same relative position, but had lost buoyancy and bridge house was totally under water. Forefoot was visible and only 100 feet of deck aft of forecastle break were above water. Unable to see any pollution due to spray and waves. Due to weather and probable icing aboard, it was recommended no operation be performed this day.

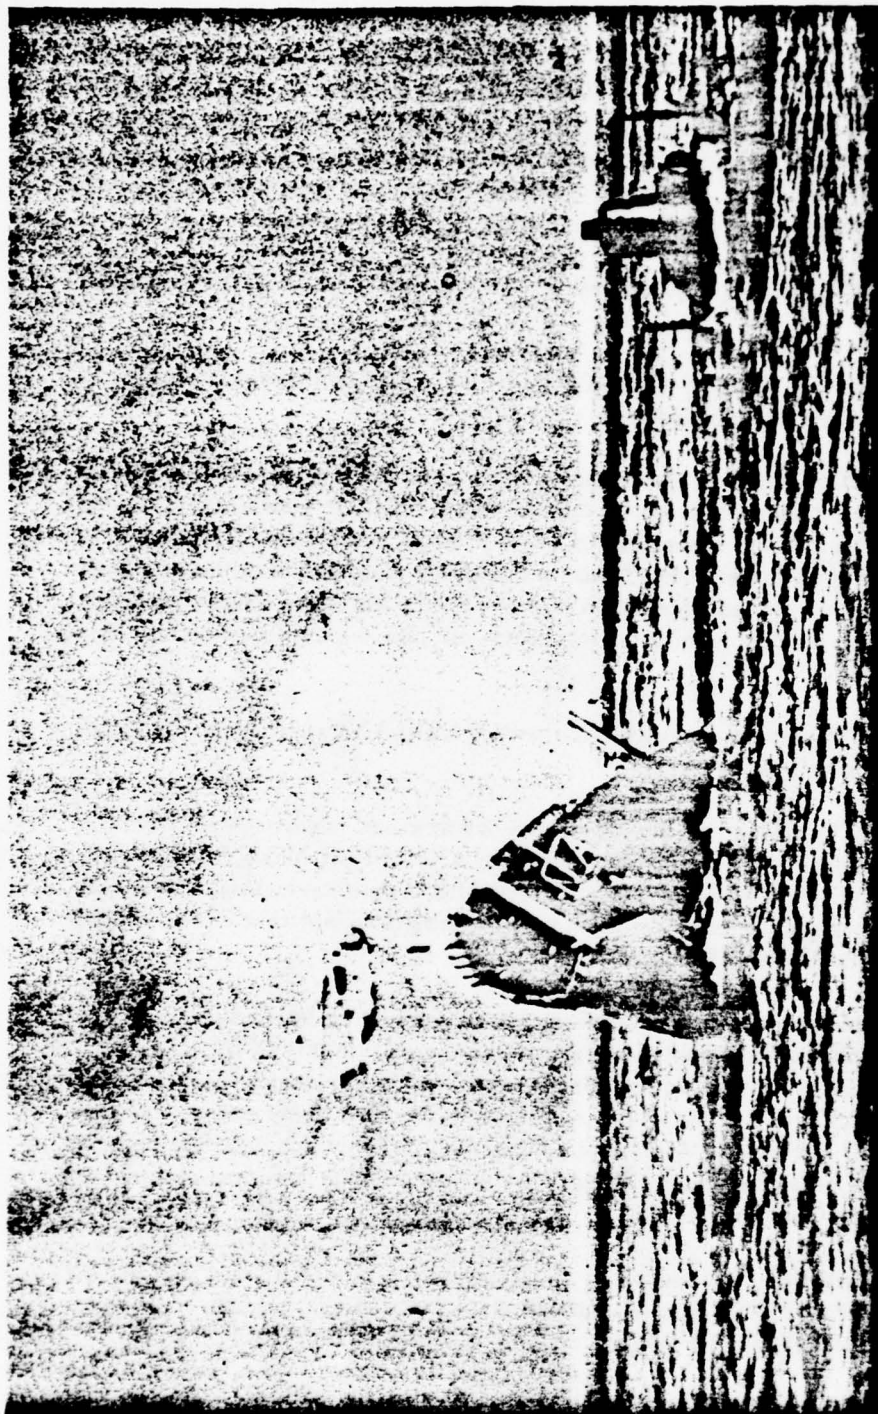
FIGURE 11 ARGO MERCHANT ON 23 DECEMBER 1976

- 0805 Close observation showed stern and bow sections unchanged. Bow was inclined 40 degrees above horizontal (Figure 11). Four mooring buoys were in place. No sign of either Yokohama fenders. Swells were putting seas and spray up to stack and fore-castle break. Pollution tended 045°T and consisted of irregularly shaped black patches of heavy oil 2 inches thick, plus areas of brown thin 1/4-inch surface oil and a wide plume of sheen. Significant part of oil was coming from stern section.

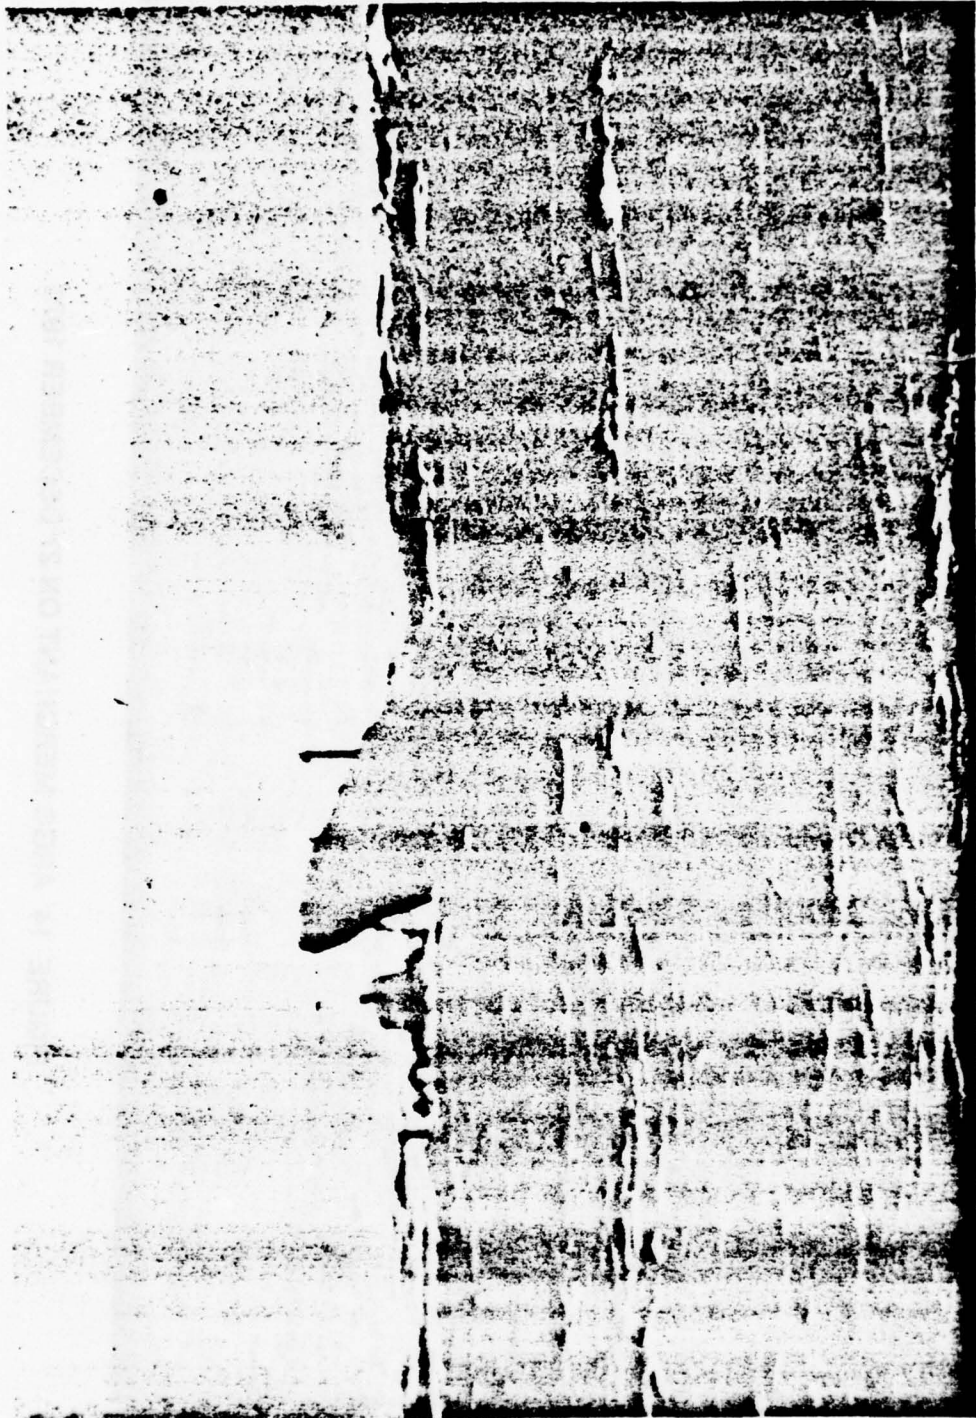
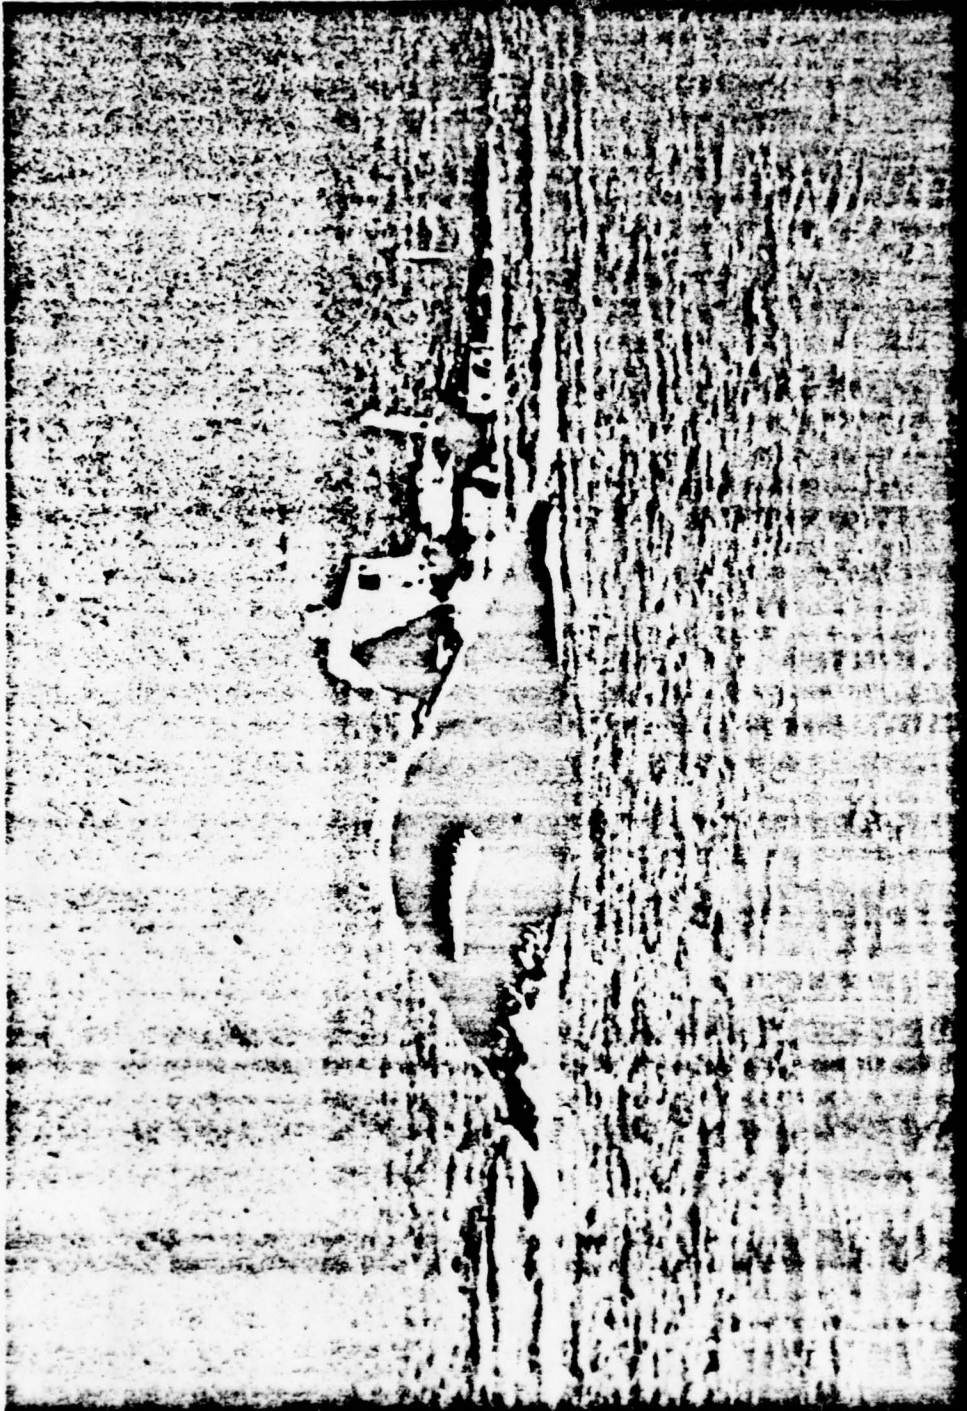
- 2200 Examination with search light revealed bow section turned over and sunk. Unable to determine details due to heavy weather; however, 50 feet of bottom and 10 feet of stem remained above the water. Pollution not observed due to darkness. Figures 13 and 14 provide a view of wreck taken on 27 December.

FIGURE 13 ARGO MERCHANT ON 27 DECEMBER 1976

FIGURE 14 ARGO MERCHANT ON 27 DECEMBER 1976

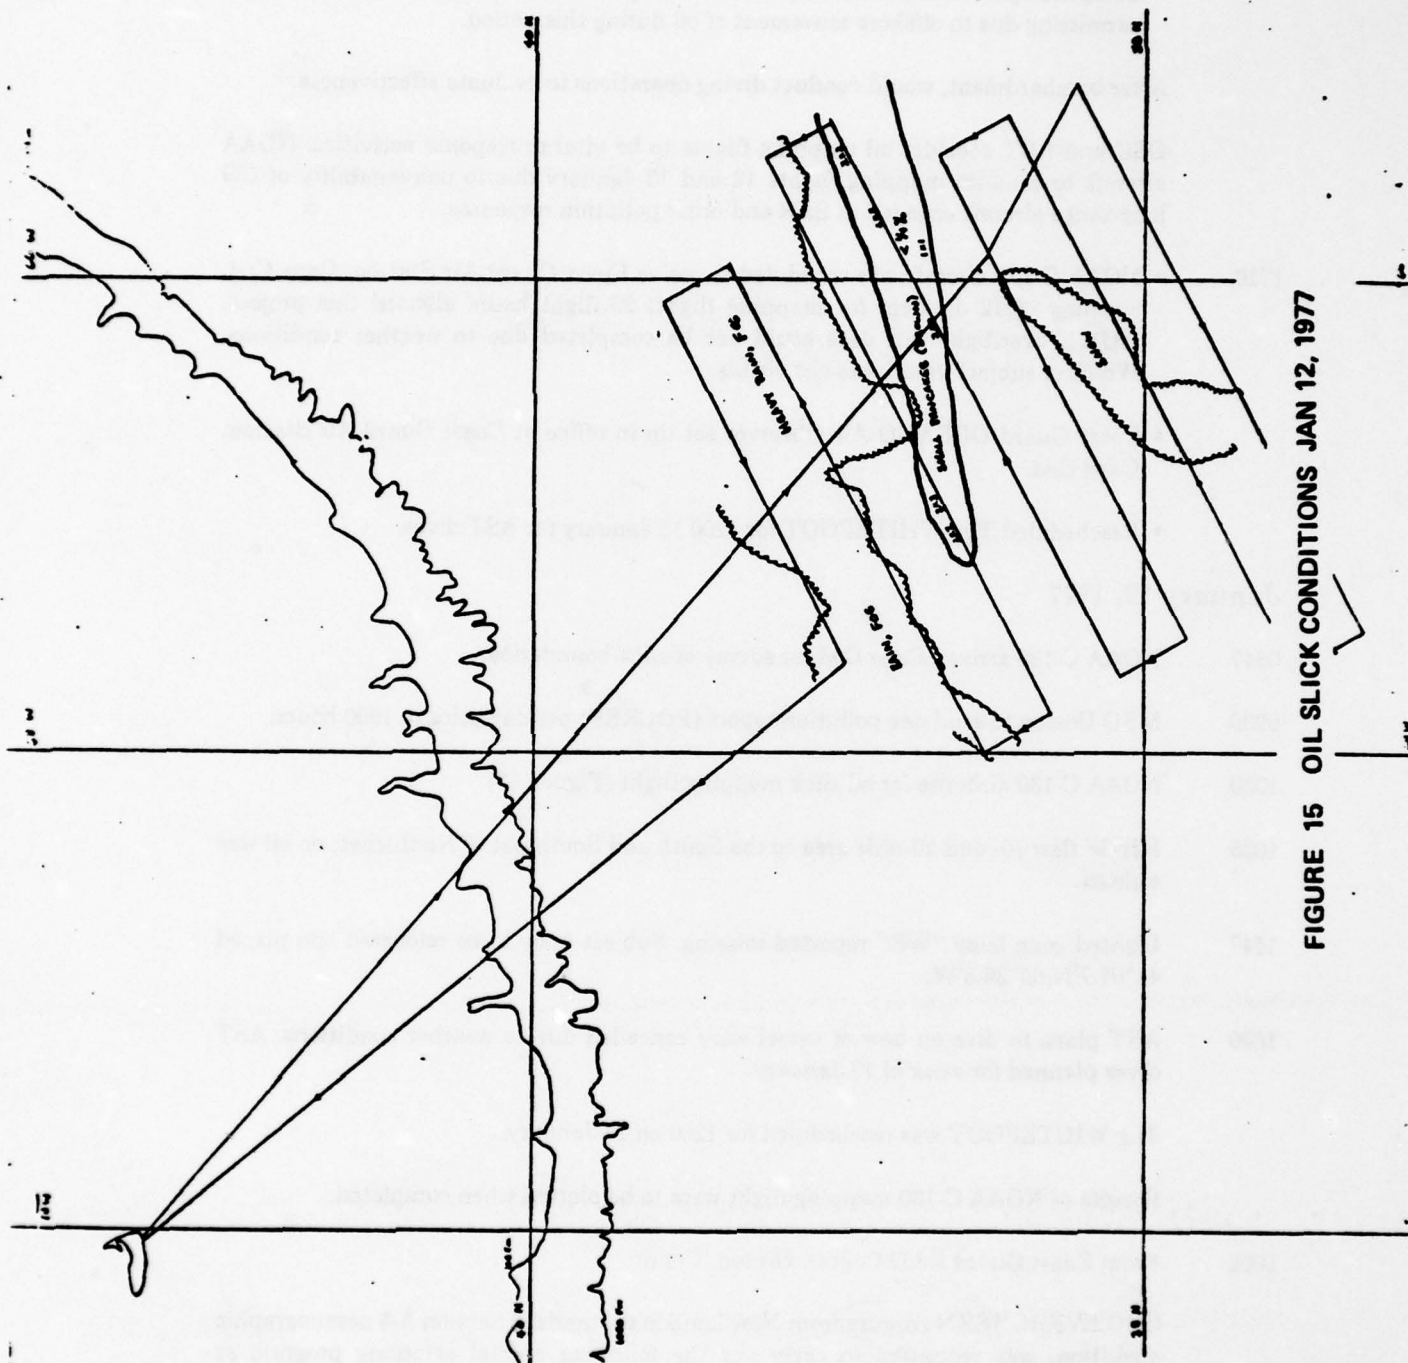
- 0847 NOAA C-130 arrived Cape Cod for survey of slick boundaries.
- 0930 MSO Boston to send one pollution report (POLREP) per day prior to 1600 hours.
- 1030 NOAA C-130 airborne for oil slick mapping flight (Figure 15).
- 1035 HH-3F flew 10- and 20-mile area to the South and Southeast of Nantucket; no oil was sighted.
- 1547 Lighted gong buoy "WR" reported missing. Subject buoy to be relocated and placed 41°01.7'N, 69°26.8'W.
- 1600 AST plans to dive on bow of vessel were cancelled due to weather conditions. AST dives planned for week of 17 January.

FIGURE 15 OIL SLICK CONDITIONS JAN 12, 1977

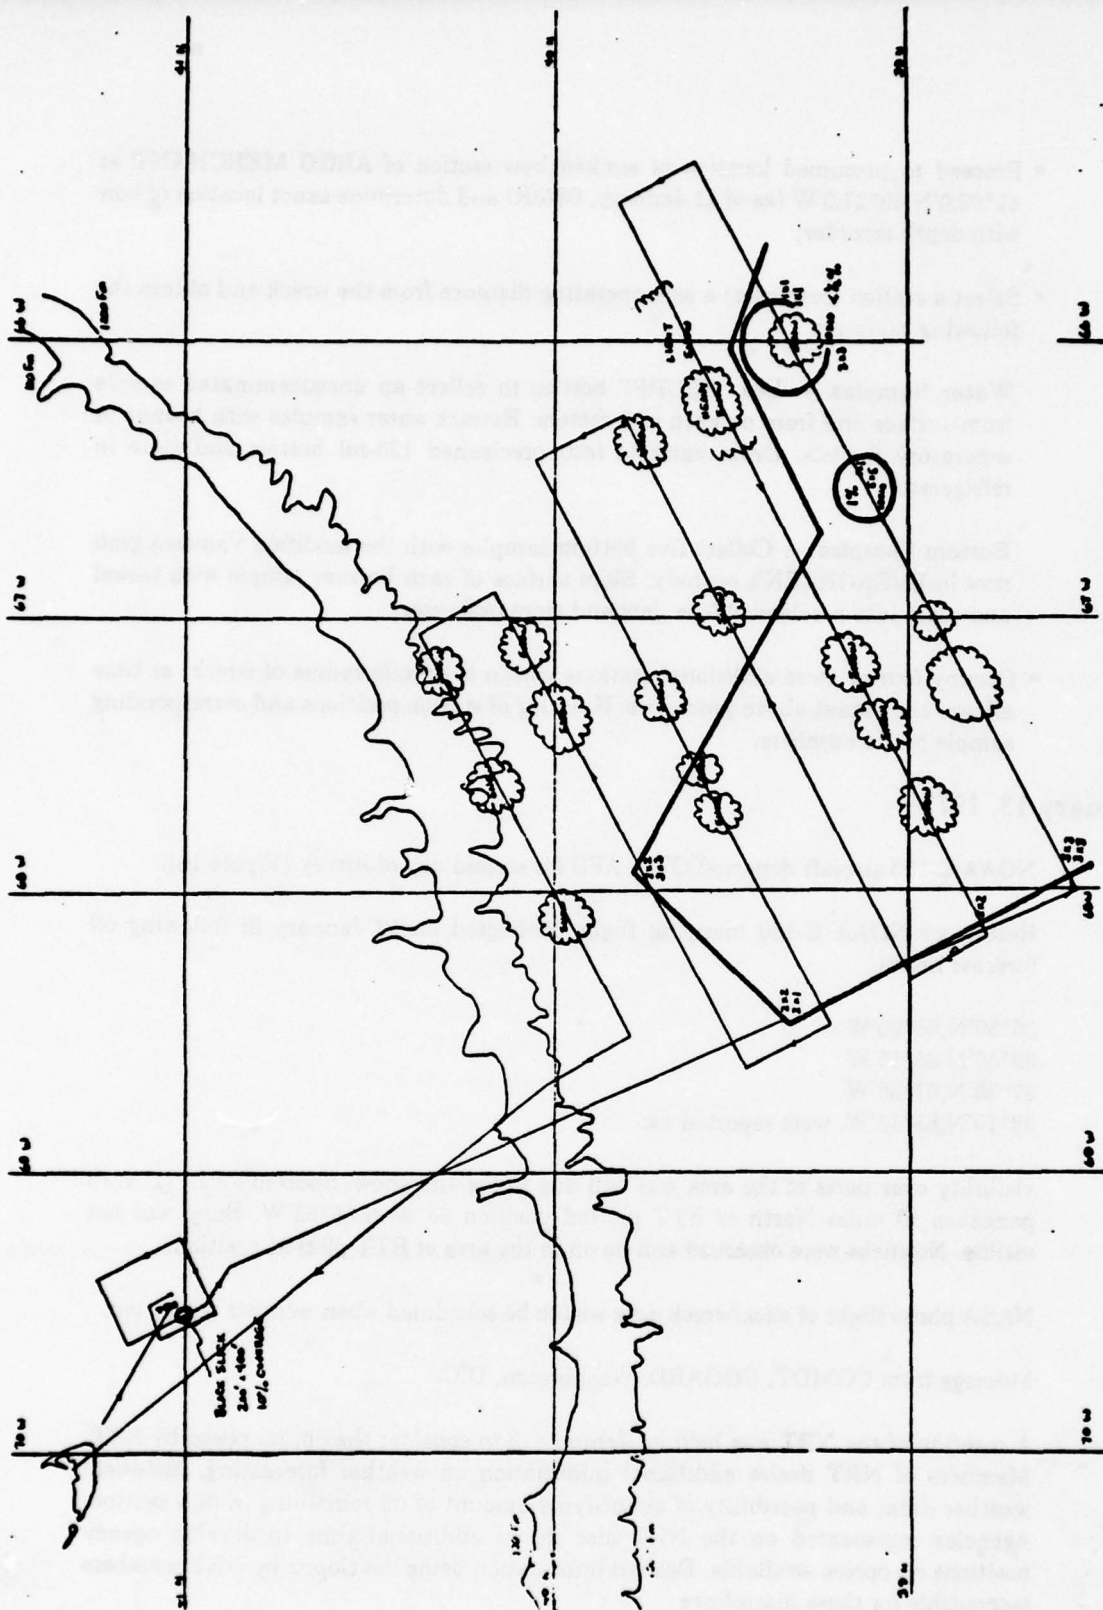
- 1037 NOAA C-130 aircraft departed OTIS AFB for second day of survey [Figure 16].
- 1055 Results of NOAA C-130 mapping flight conducted on 12 January in following oil forecast limits:

FIGURE 16 OIL SLICK CONDITIONS JAN 13, 1977

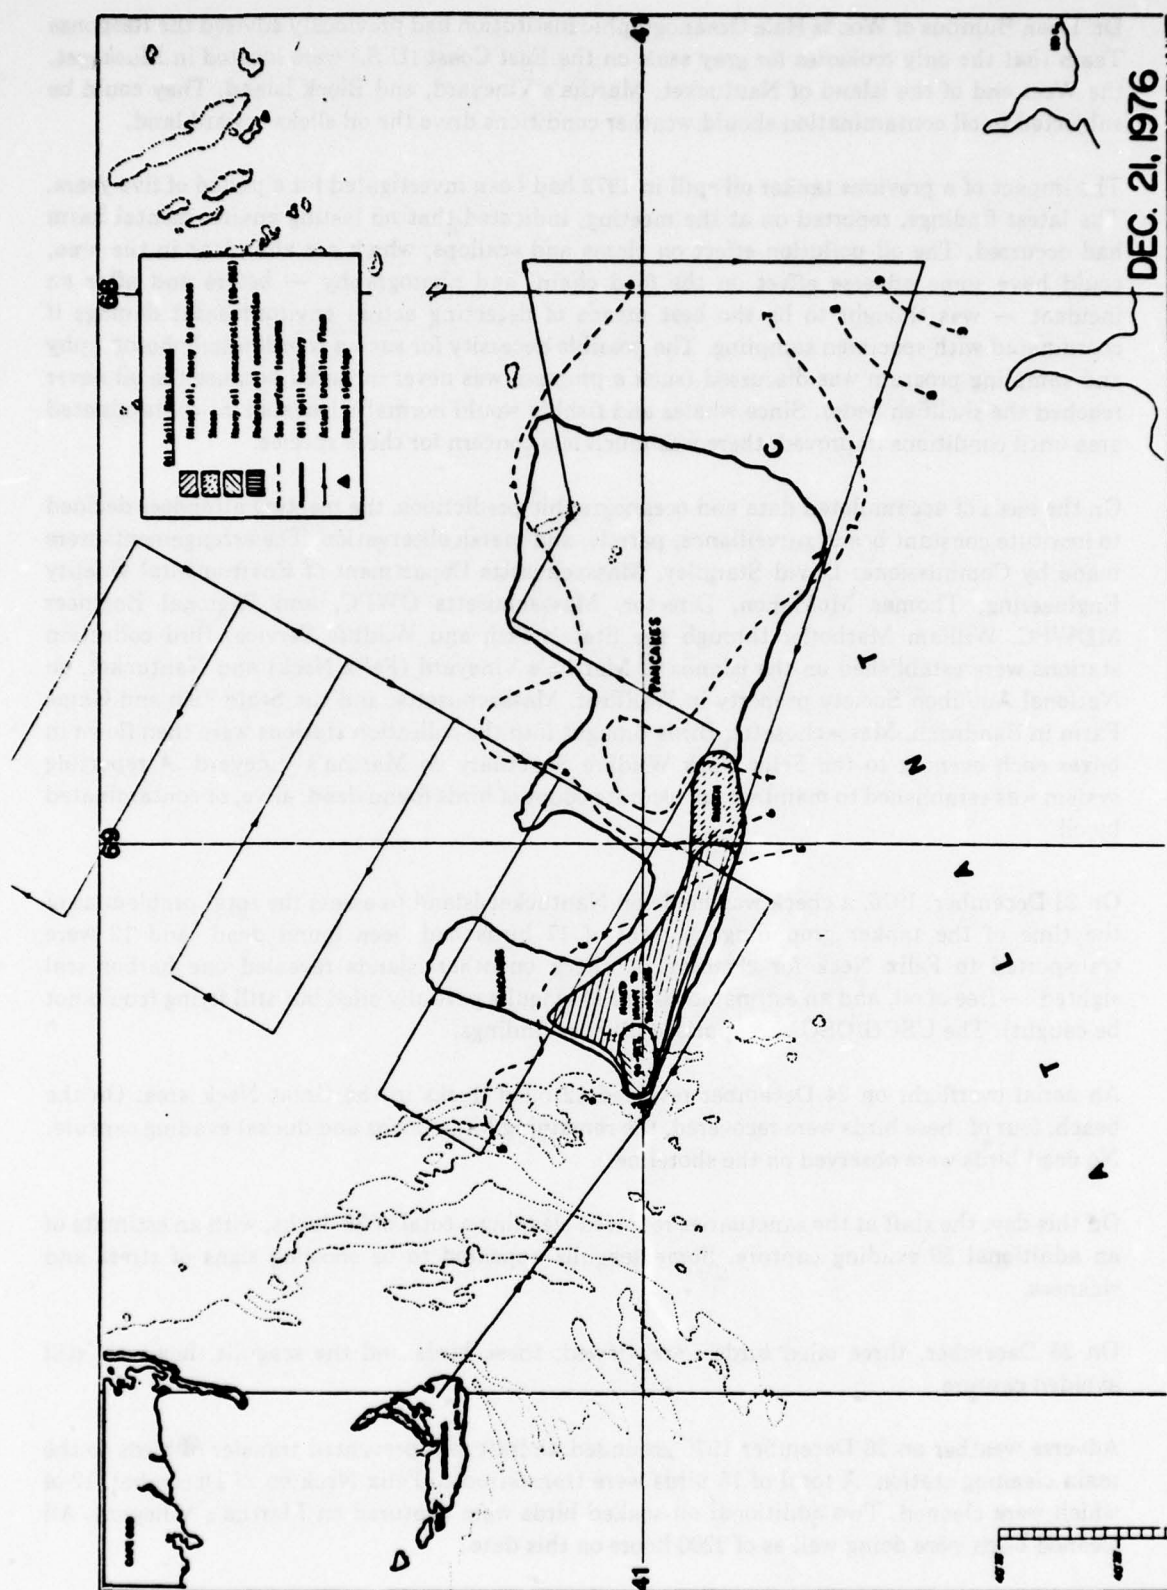
Technical, environmental, offshore, and supply conditions were such that none of the suggestions could be implemented before the vessel broke up and released her No. 6 oil cargo. Once it was established that weather conditions were, in fact, protecting the U.S. coastline (Figure 18) and that no other remedial action could be introduced, natural dispersal at sea was considered by all concerned to be the best recourse.

FIGURE 18 TRAJECTORY OF OIL SLICK FOLLOWING BREAK-UP OF ARGO MERCHANT
